THE
GREAT EARTHQUAKE
OF JAPAN

1891.

BY
JOHN MILNE.
AND
W.K. BURTON.
PLATES BY K. OGAWA.

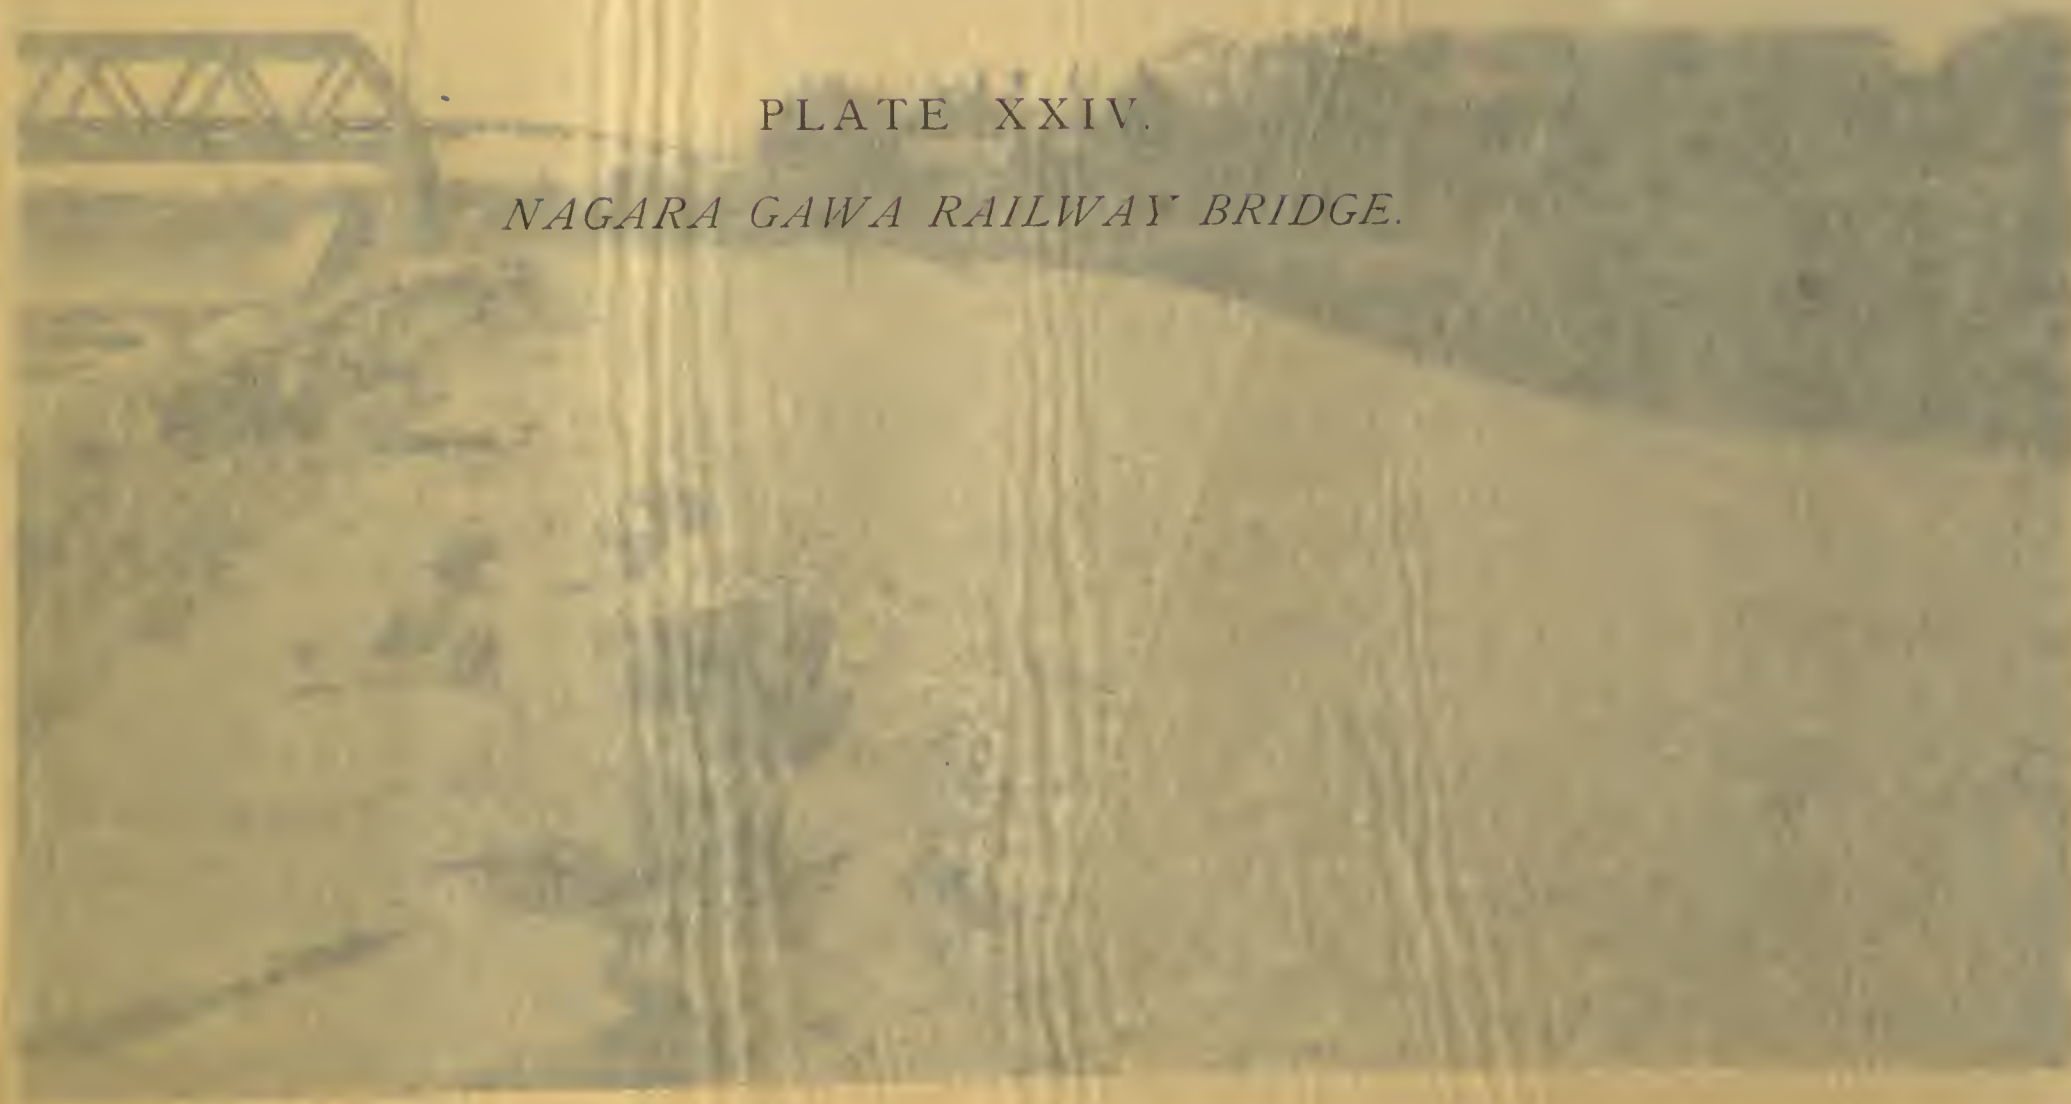
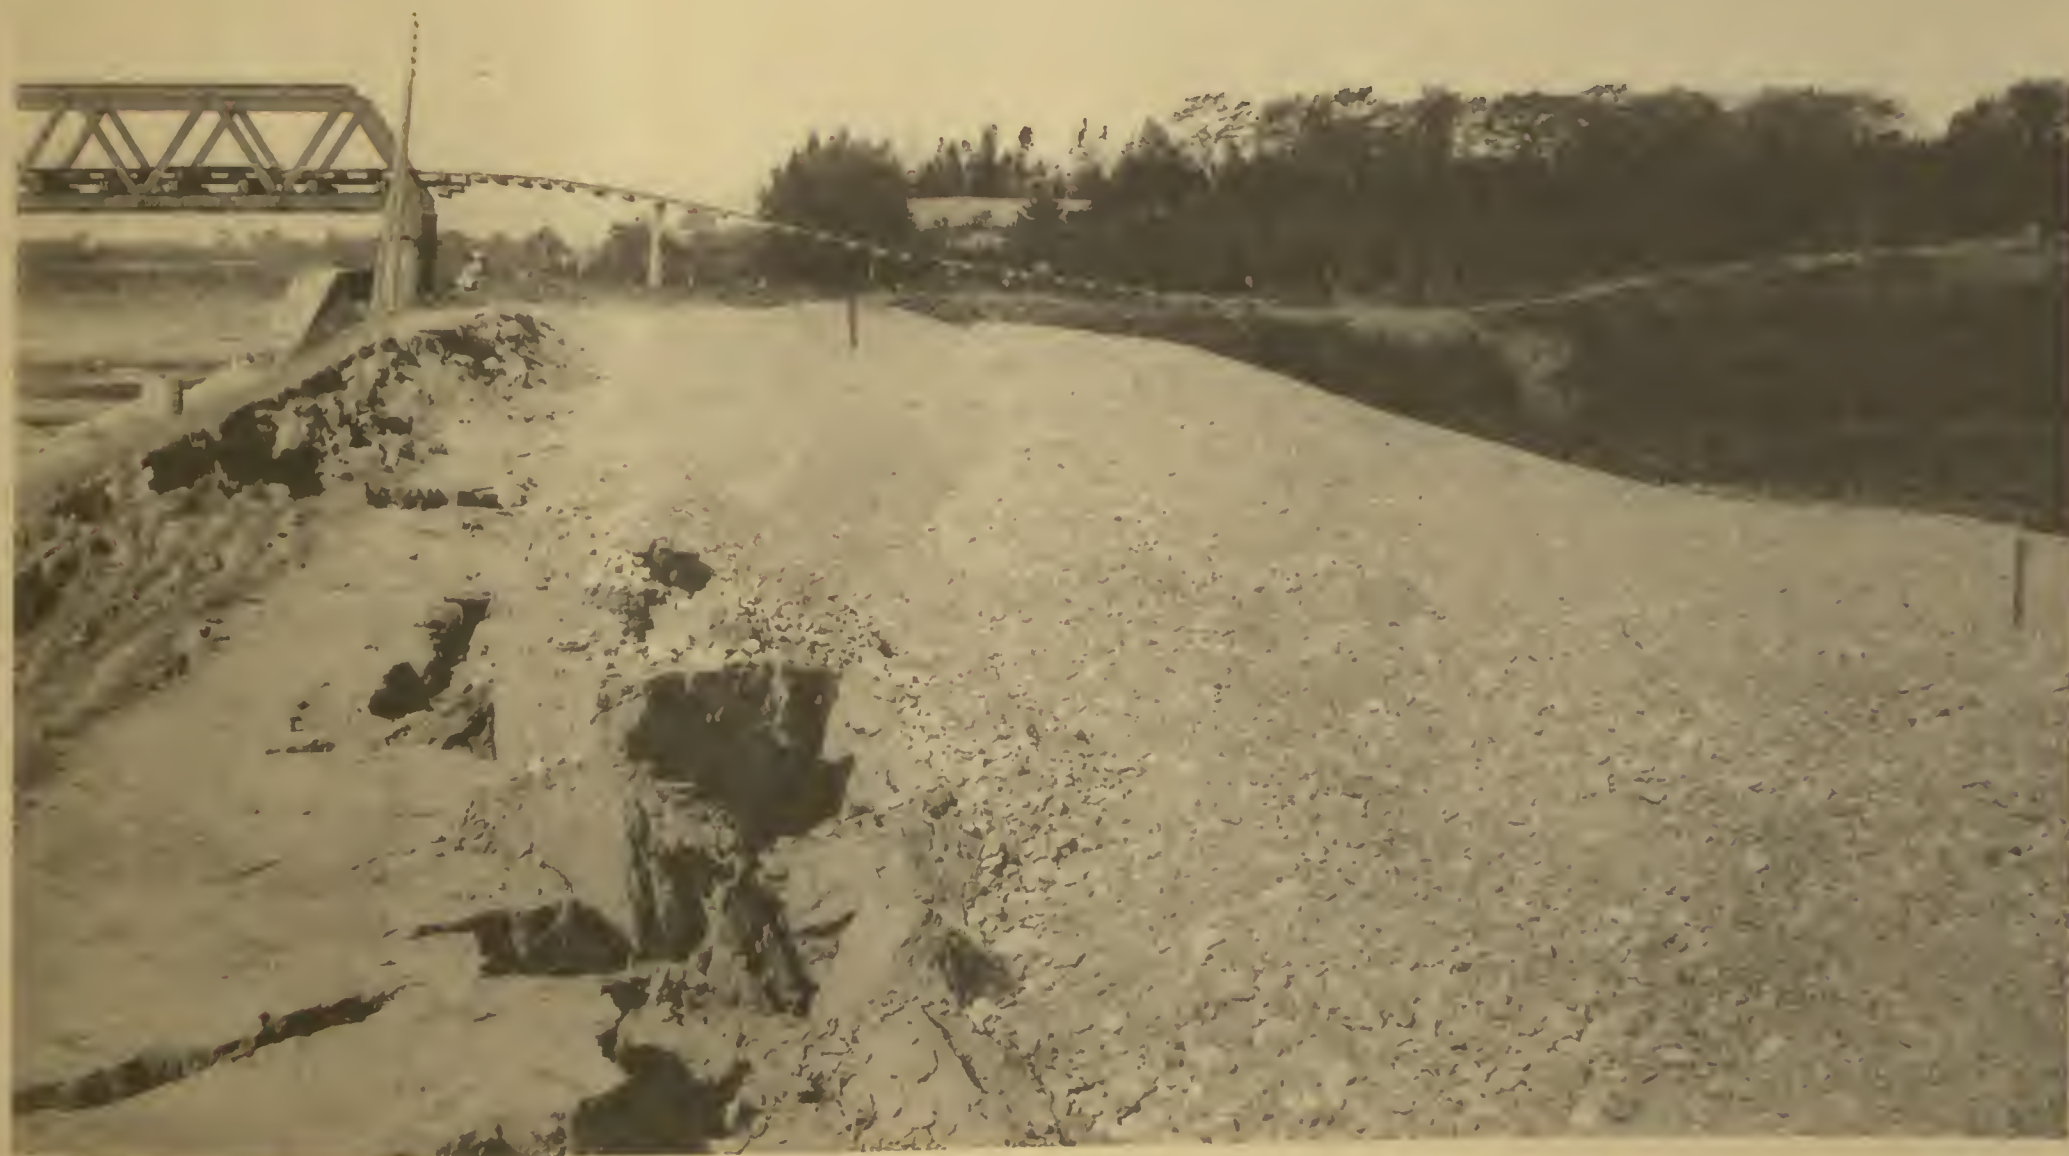
PLATE XXIV.

The disappearance of embankments, as for instance near to the abutments of many bridges, is undoubtedly due to the shaking away of the loosely cohering materials out of which they were constructed.

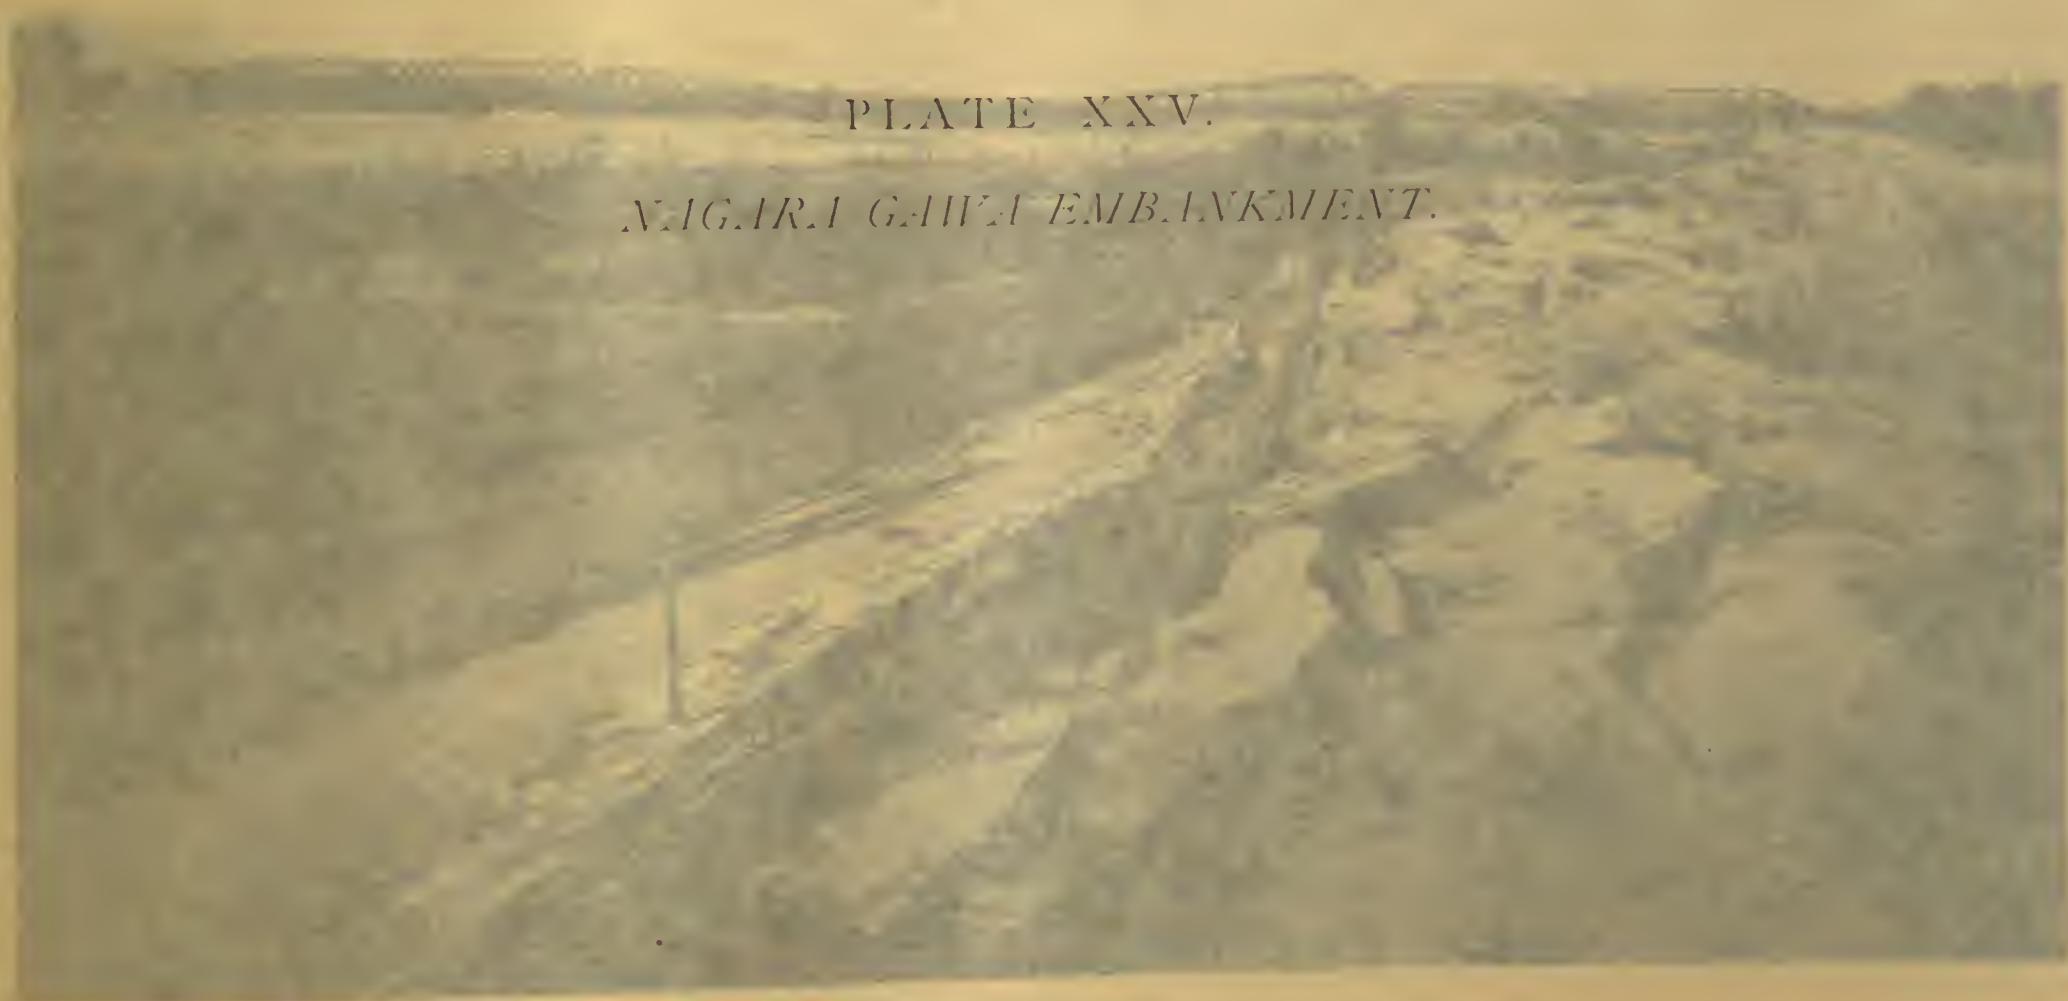
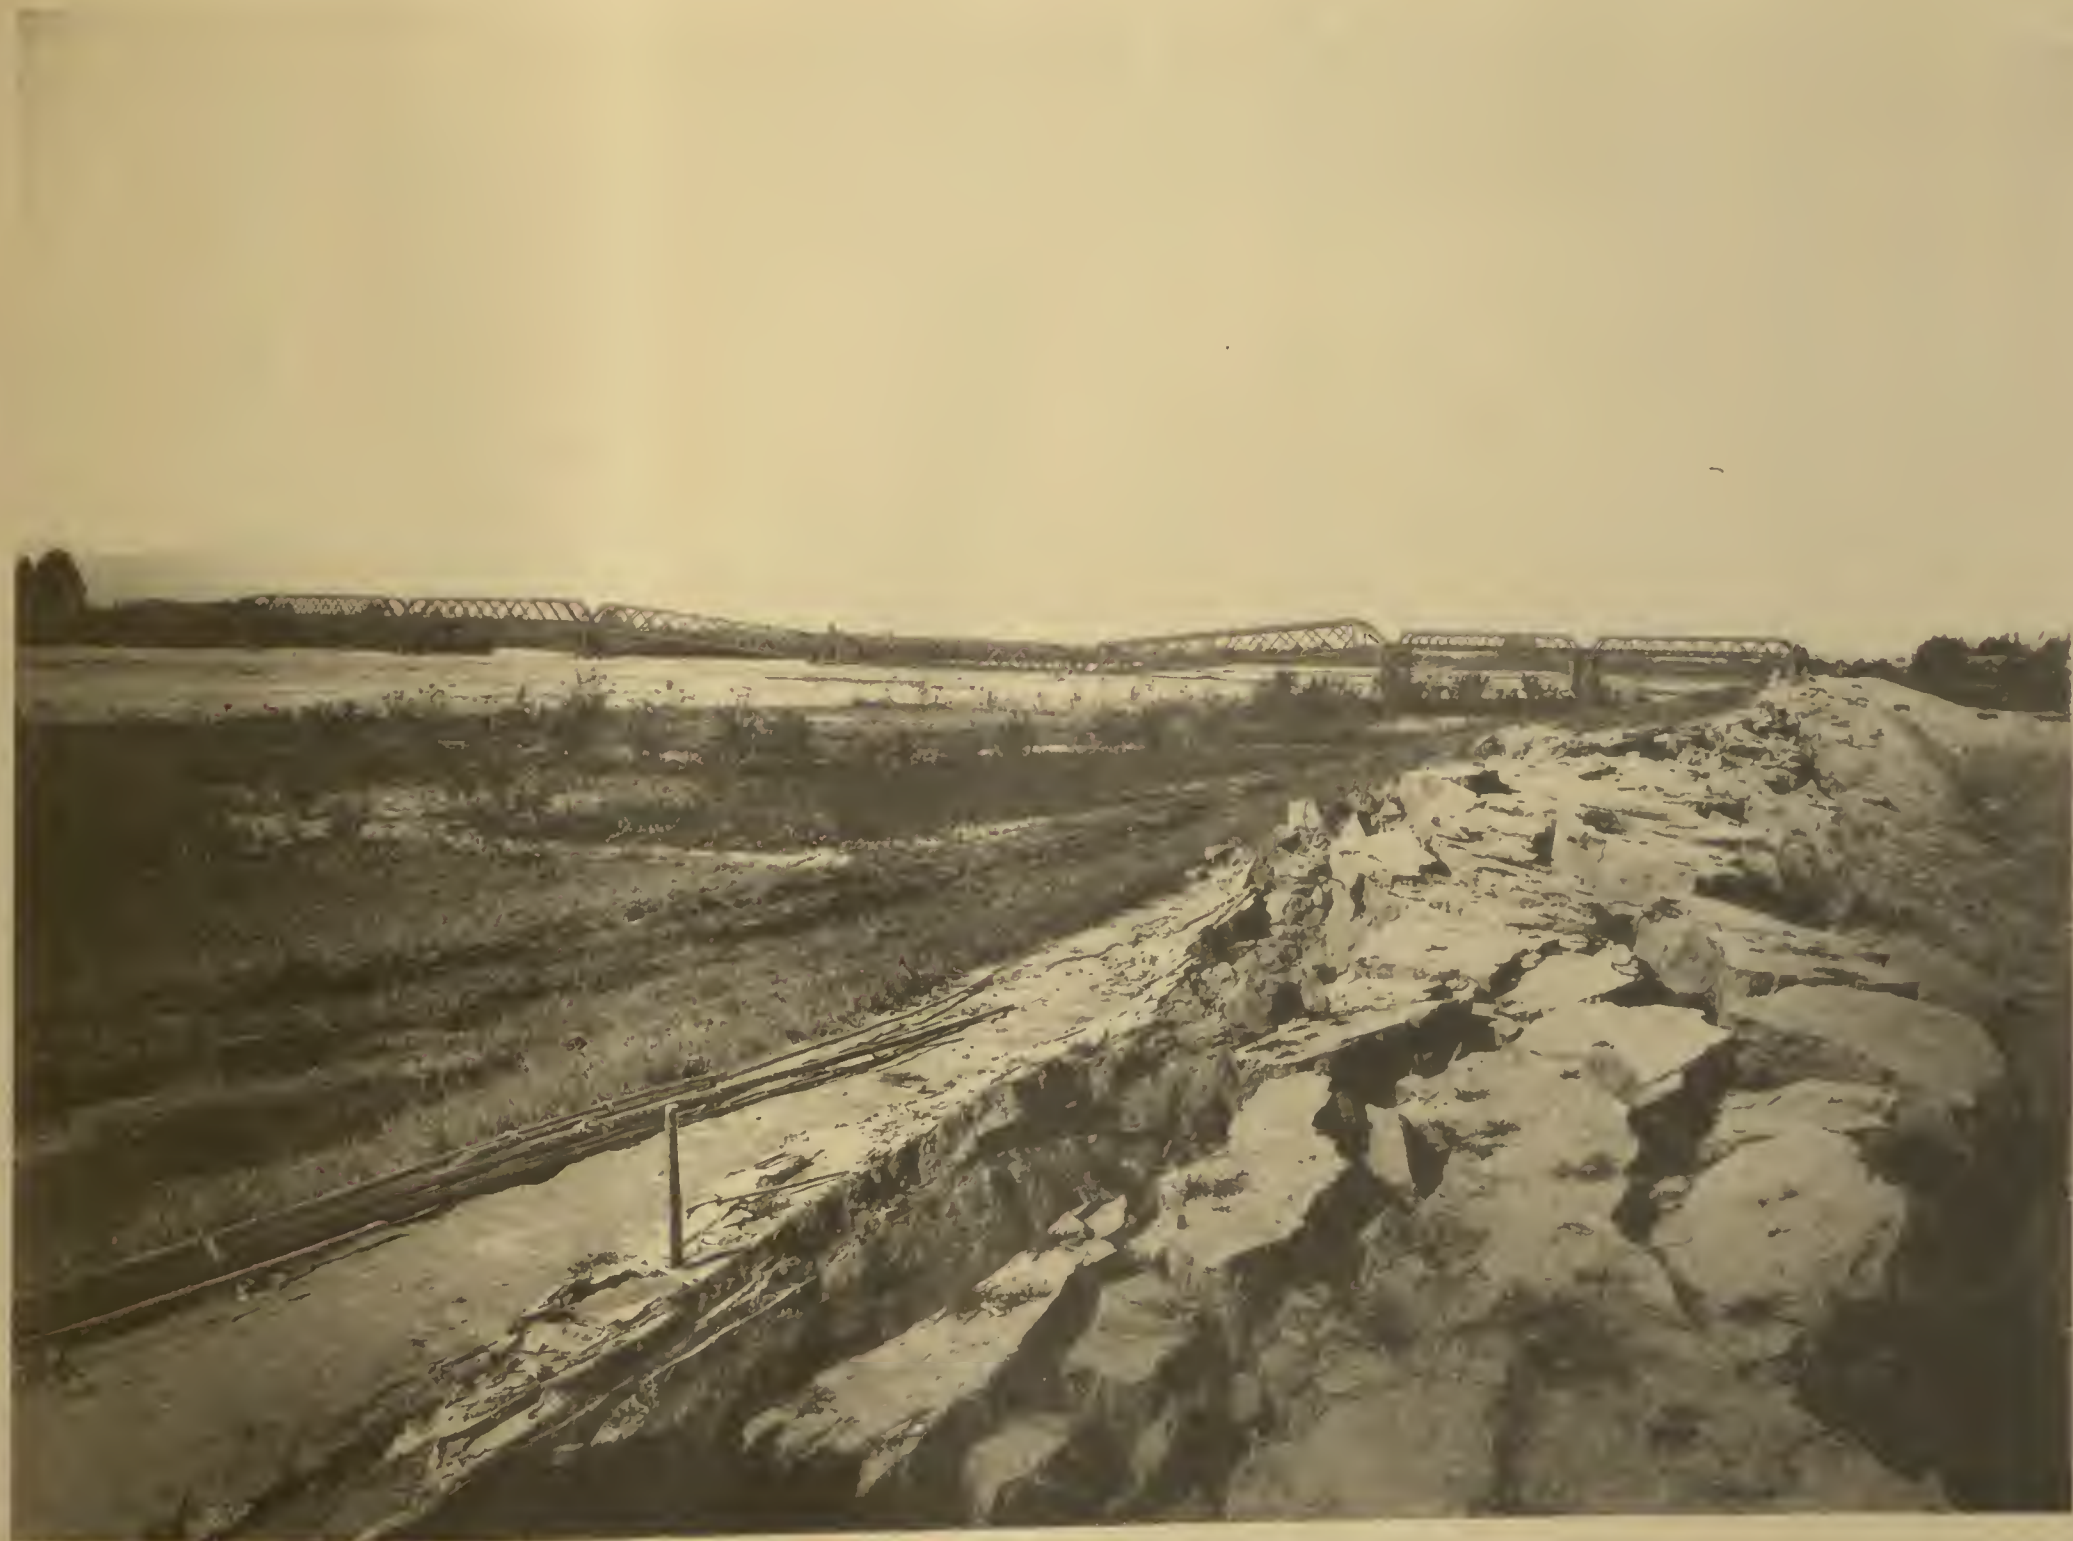
PLATE XXV.

The longer piers have suffered most. When looking at the illustrations of the railway bridges which were designed by Mr. C. A. W. Pownall, M.I.C.E. it must be remembered, that, for five years, not only have they withstood all ordinary traffic, but they have been subjected without injury to unusually heavy floods, which have devastated the surrounding country, and have withstood the force of typhoons which have overturned locomotives and caused the collapse of many brick chimneys and buildings.

Where river banks have not been levelled by the shaking outwards of the materials of which they were built, they have been fissured and reduced to the chaotic state shewn in the picture.

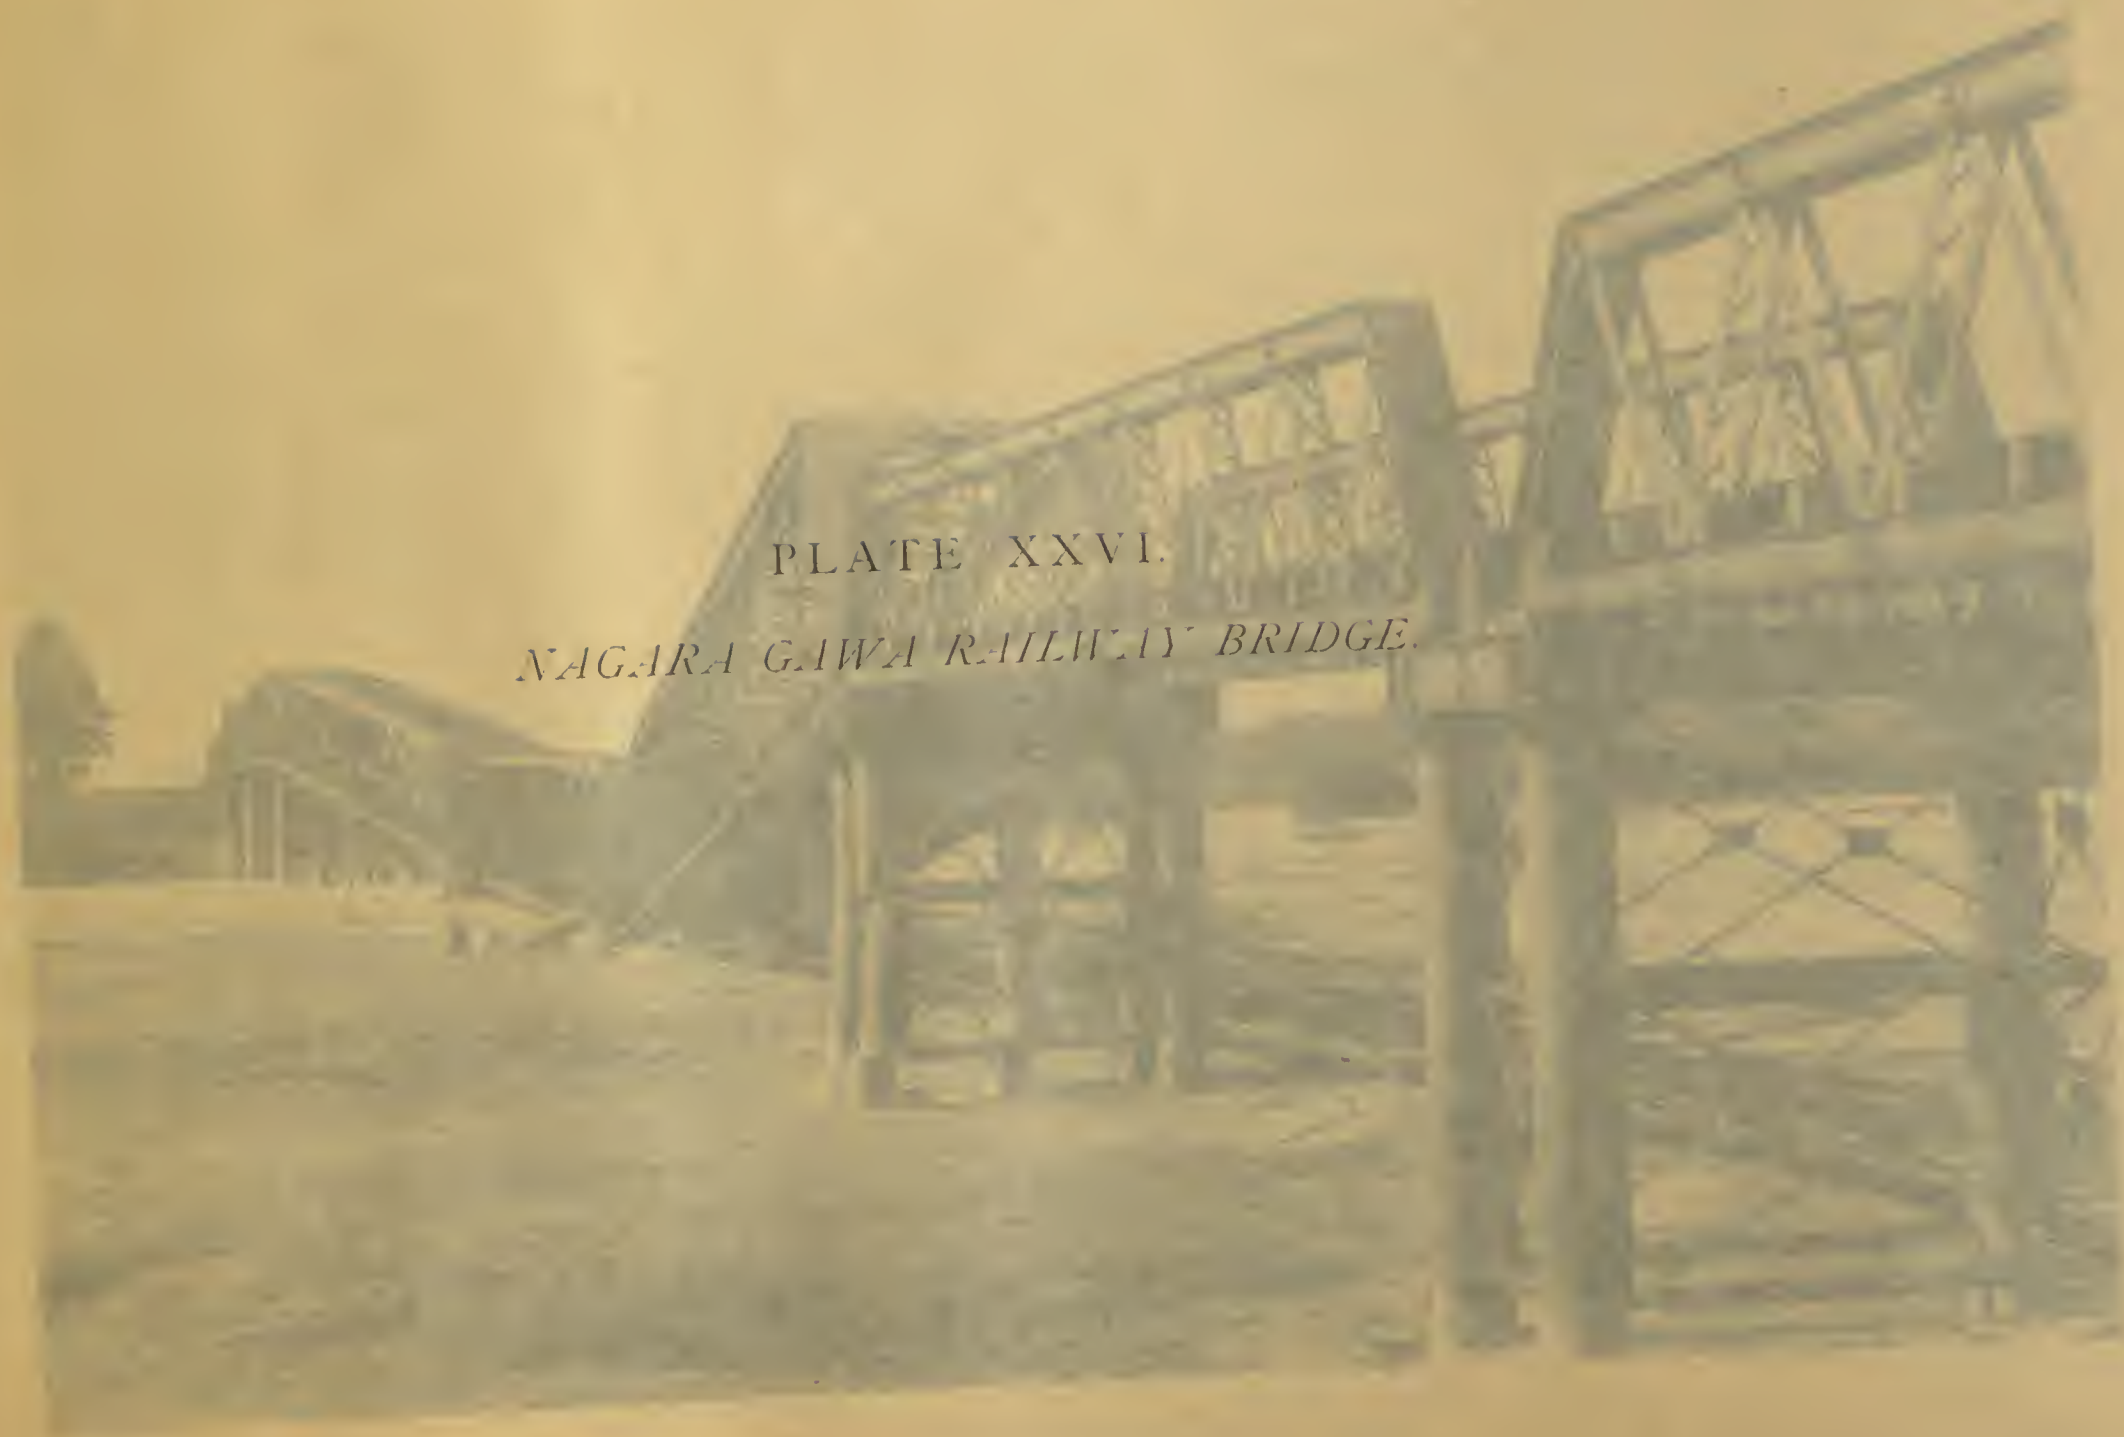
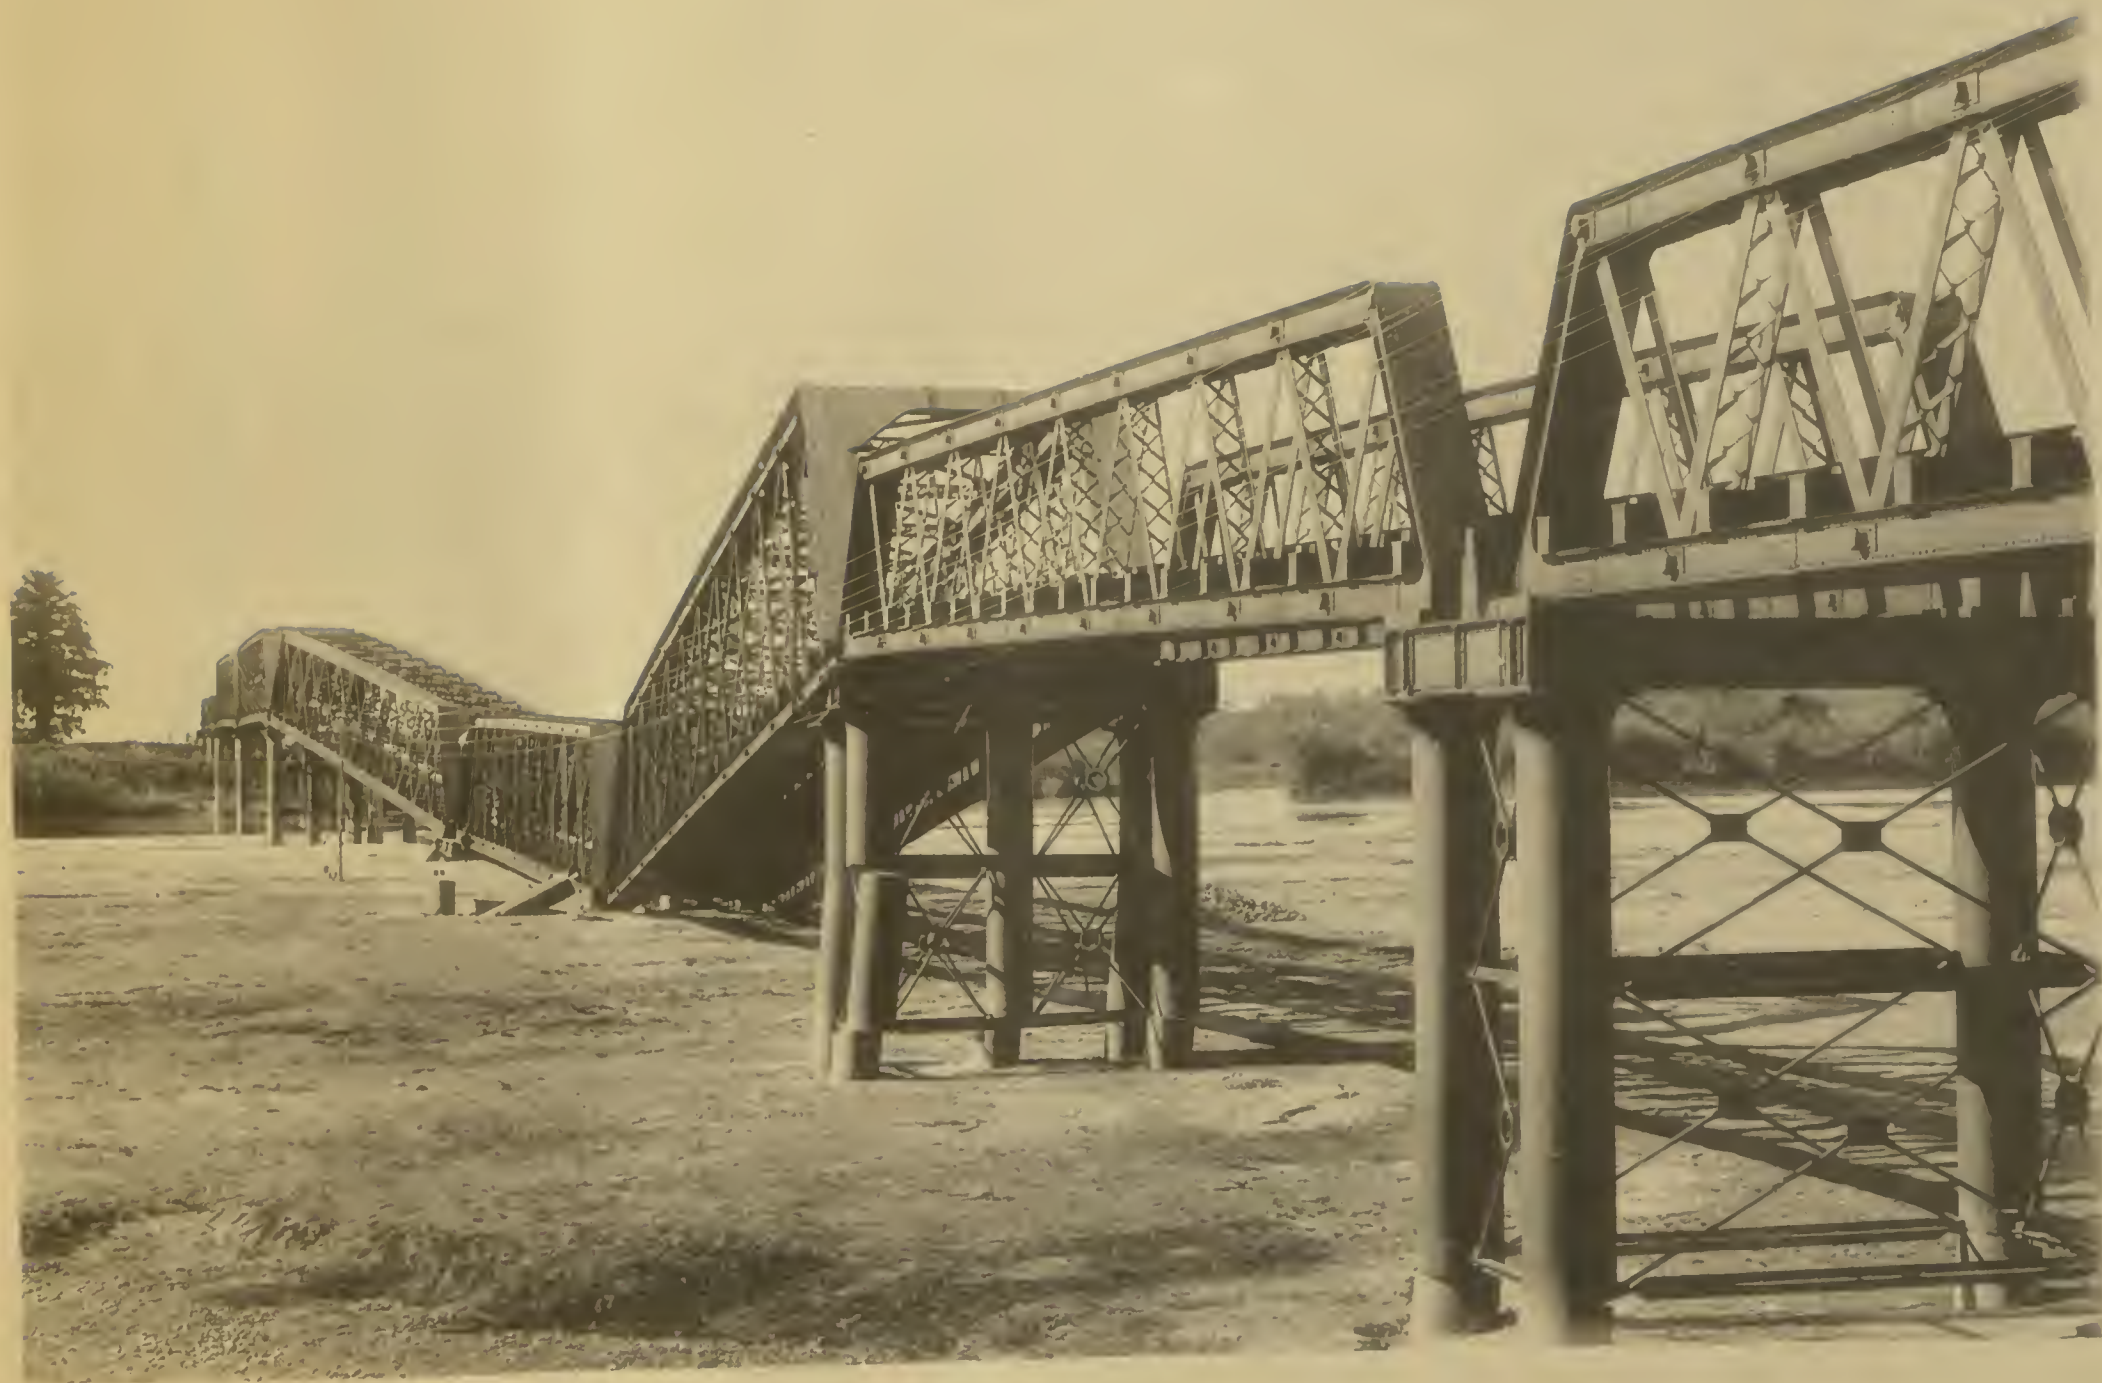
PLATE XXVI.

If near a river bank, where the piers are short and have stood, we can say, that the suddenness with which they were moved must have been *less* than so many feet per second; whereas, in the middle of a stream, where the piers are relatively high and have been fractured, the suddenness of motion must have been *more* than so many feet per second.

A bridge which has been partially destroyed by an Earthquake therefore becomes a seismometer, and leads to the determination of the rate at which motion was applied, a factor of considerable importance in designing future constructions.

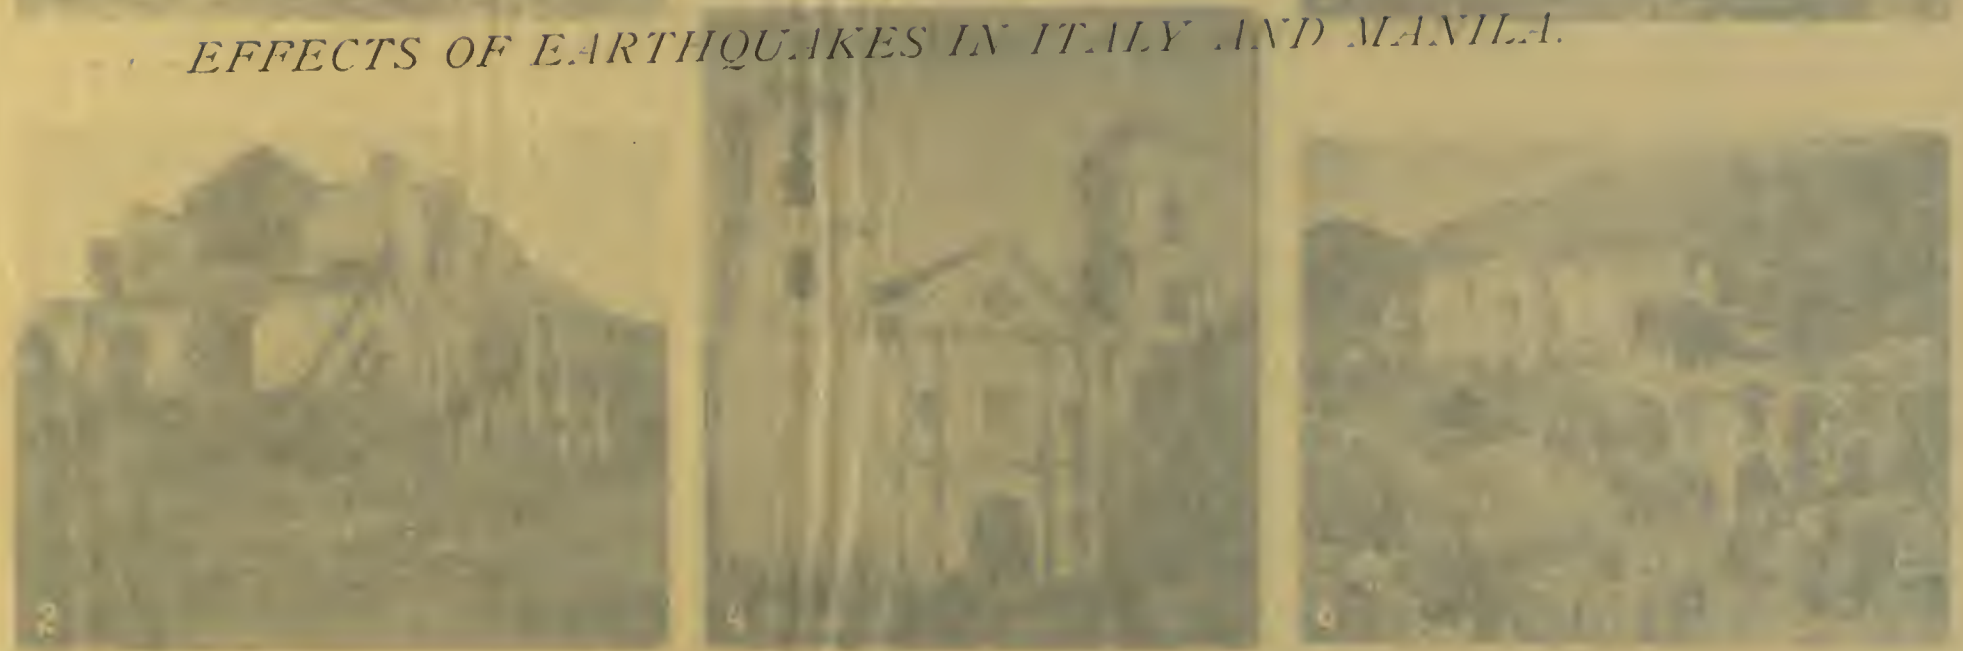
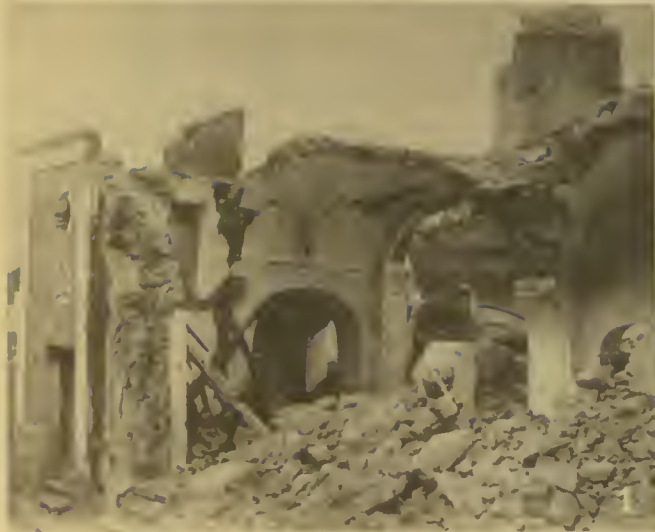
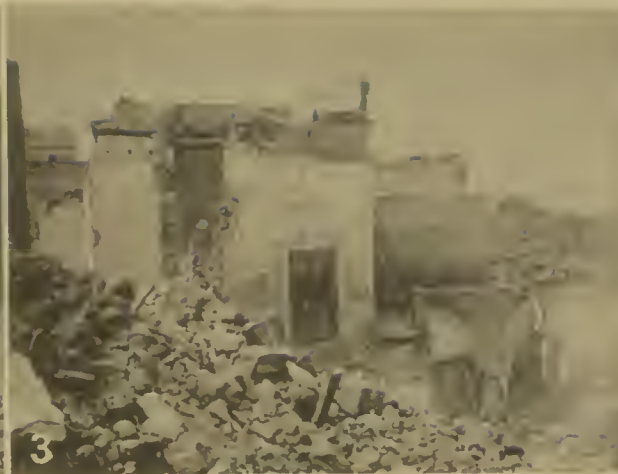
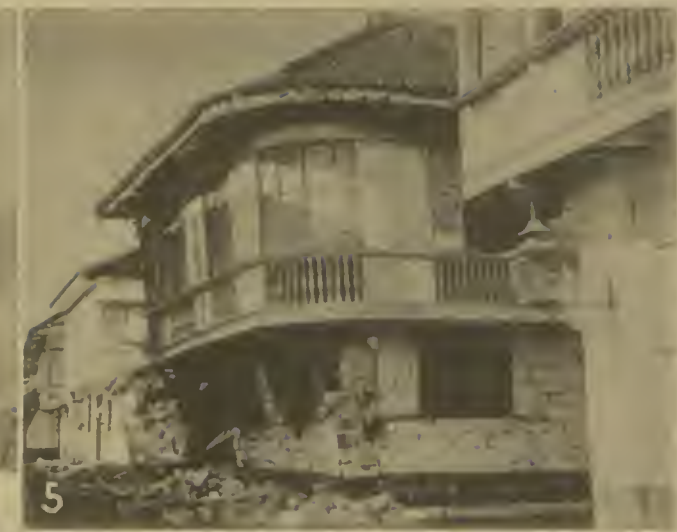
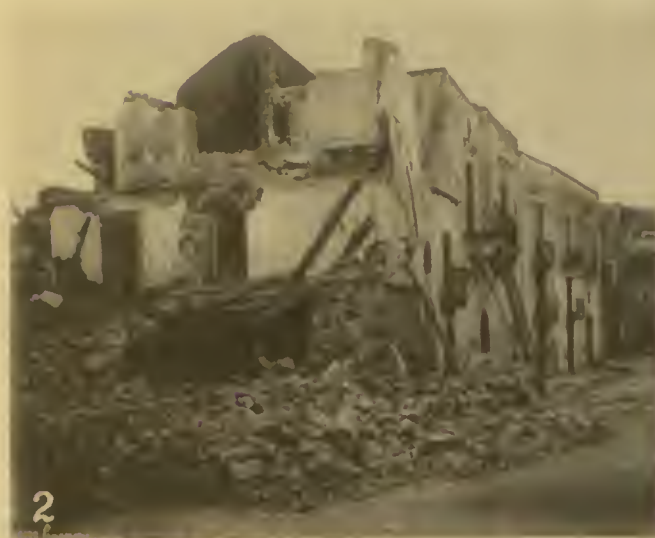
PLATE XXIX.

EFFECTS OF EARTHQUAKES IN ITALY AND MANILA.

Although the plate may be regarded as illustrating the unsuitability of archwork in Earthquake countries, it will be observed that the masonry is mere rubble-work.

4. *Manila*.—The more or less vertical fractures in this building shew that a series of openings in a wall constitute a line of weakness; and when a building so constructed is shaken back and forth, a rending action takes place.
